Rimkus Consulting Group, Inc.
Eight Greenway Plaza, Suite 500
Houston, TX 77046
(800) 580-3228 Telephone
(713) 623-4357 Facsimile

Re: RCG File No: 11009971
LLV Number: 0209452
VMF Location: 1530 Greensmark Drive in Houston, Texas
Subject: Final Report

Rimkus Consulting Group, Inc. was retained to examine LLV 0209452, VIN 1GBCS10E4M2908832. The fire occurred on June 13, 2016 at around 12:30 P.M. the operator of the vehicle at the time of the fire, was unavailable for interview but reportedly stated the vehicle's engine died while delivering mail on his route and backfired during subsequent attempts to restart it. Soon thereafter, smoke was observed from beneath the hood as well as flames.

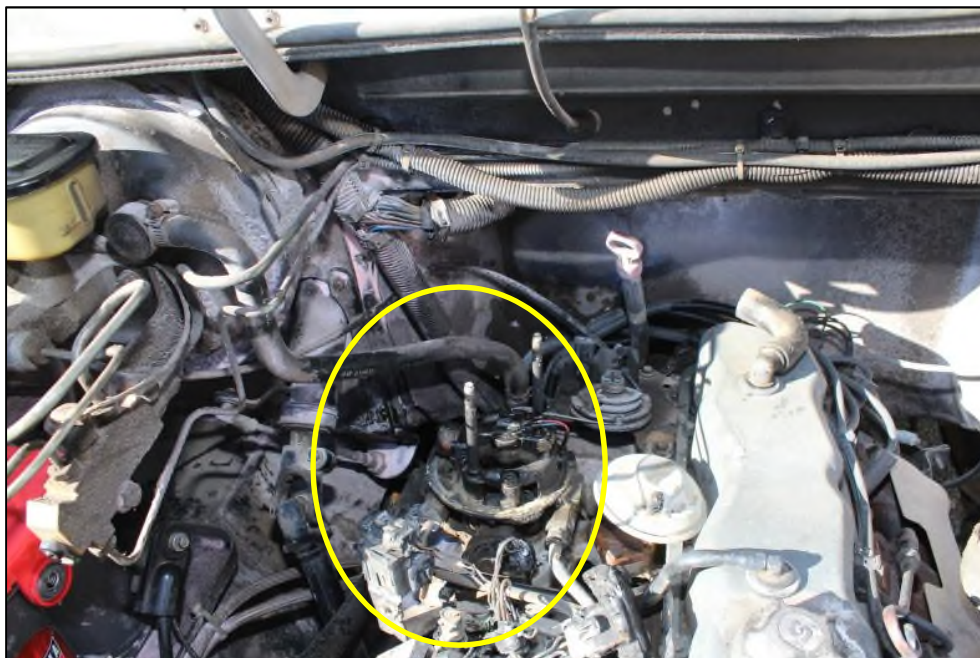
Photograph 6

Fire damage in the area of the fuel injection system.

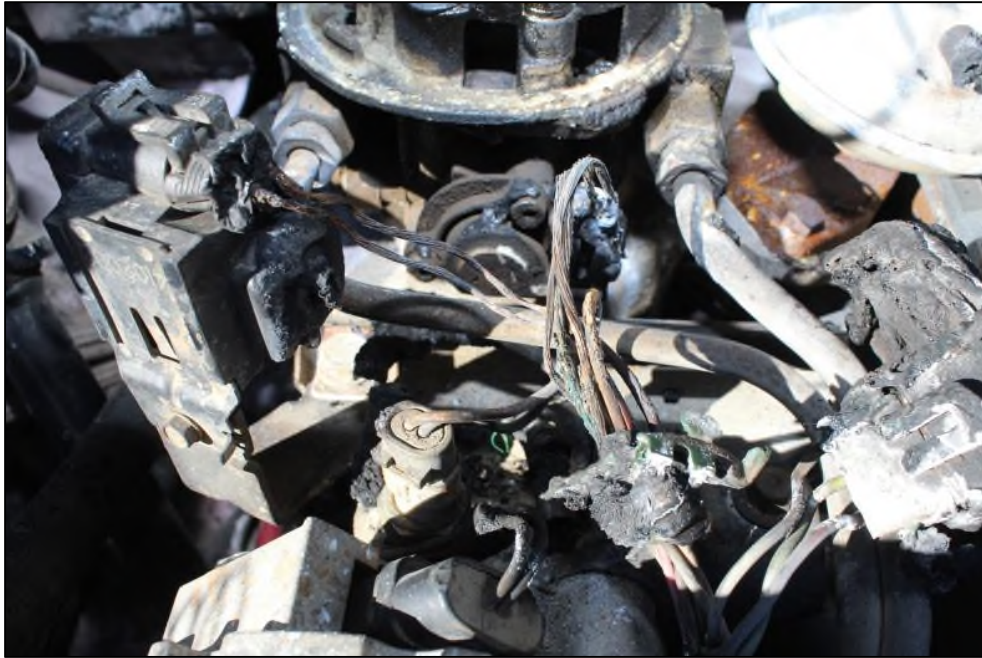
Photograph 7

Damaged electrical wiring in the area of the fuel injection system.

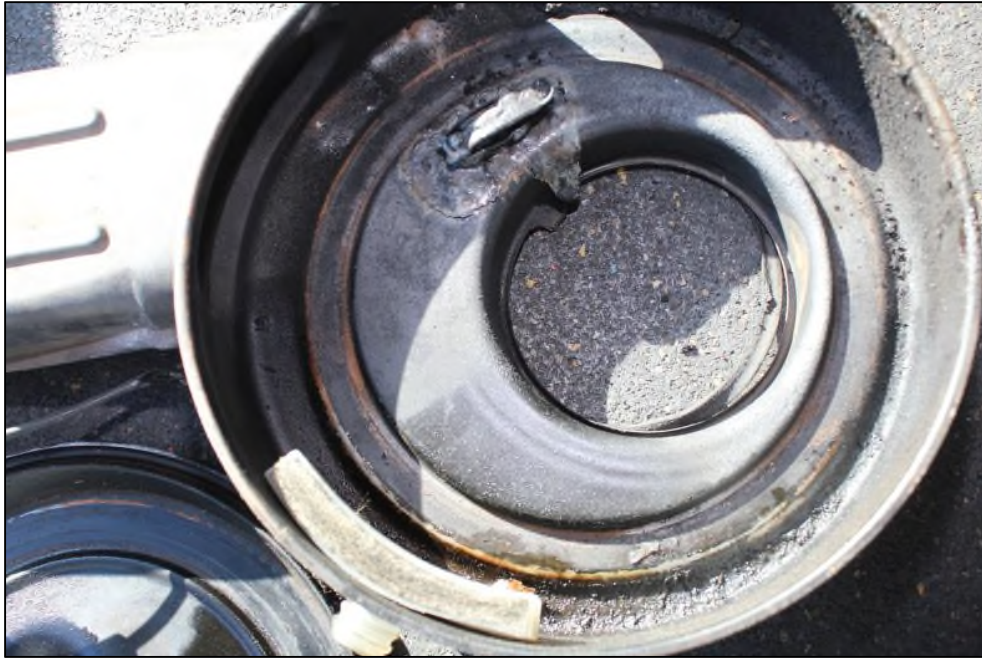
Photograph 9

Damage to the air filter housing.

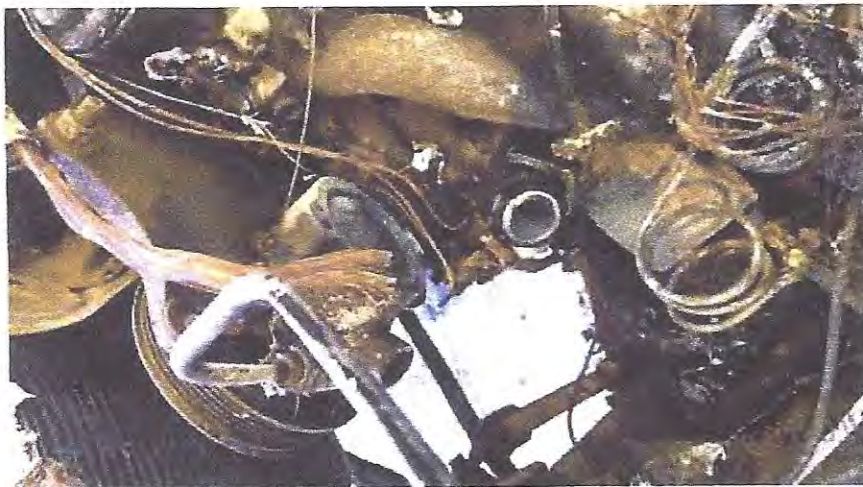
1. The area of origin for this fire was determined to be the engine compartment.
2. The point of origin was determined to be the left side of the engine where the main battery cable was attached to the engine using a metal clamp.
3. The cause of this fire is determined to be electrical in nature, with the failure of the insulation on the cable causing arcing at the clamp and heating of the wire. This wire heating raised the temperature of the cable's insulation to its point of ignition.

View of battery clamp at failure point.

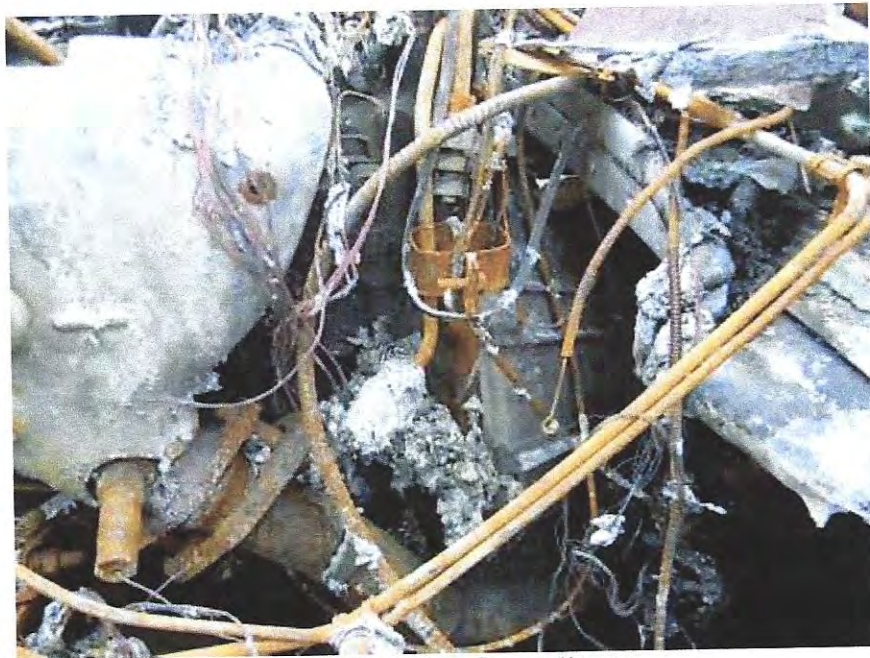
View of left side fire patterns.

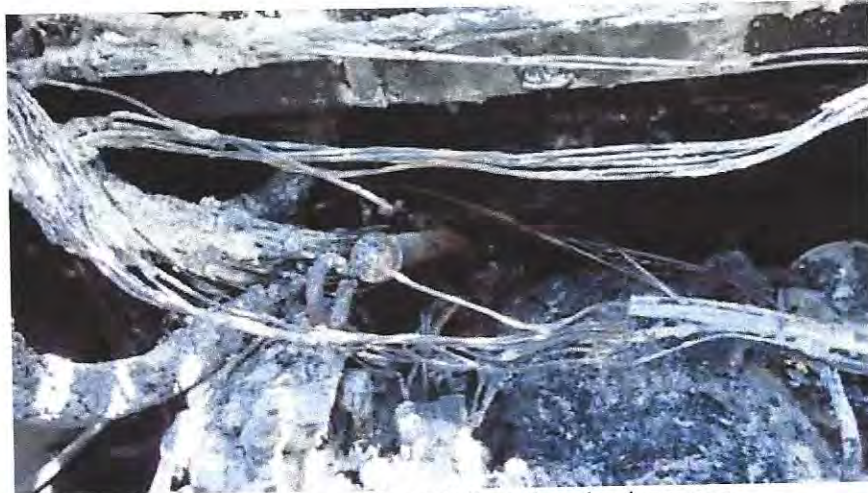
1. The origin of this fire was at the wiring harness located on the right side of the vehicle at the bulkhead.
2. The cause of this fire is determined to be the failure of the headlight wire.

Headlight power feed failure in wire harness.

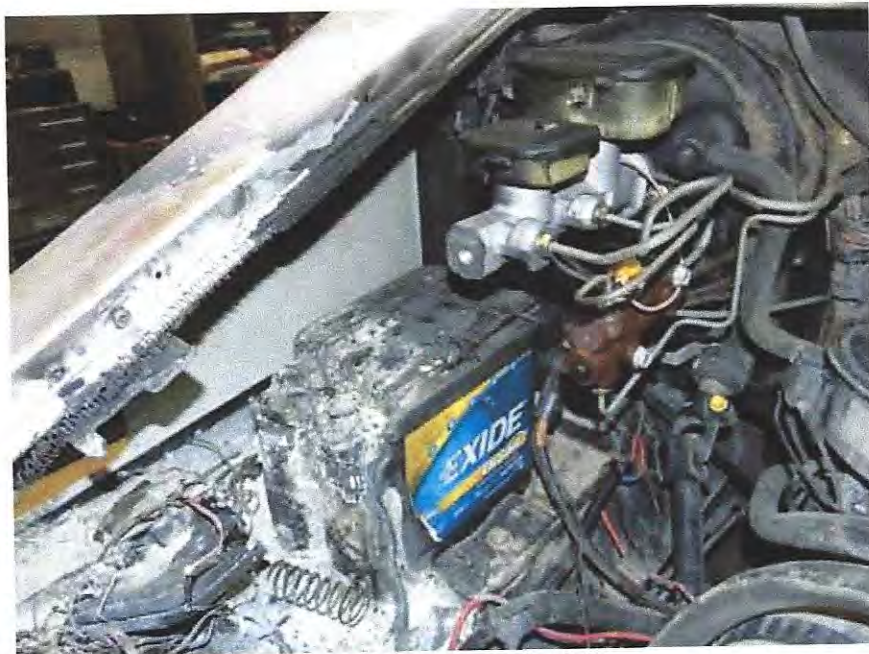
1. The area of origin for this fire was determined to be the engine compartment.
2. The point of origin was determined to be the right side marker/flasher connection located in the fender well.
3. The electrical failure of the connection caused a fault. The ignition source was fueled by the light plastic wire loom and dust accumulation within the fender well.
4. The cause of this fire is determined to be an electrical failure, with the failure of the connection of the side marker/flasher in the fender well.

View of the area of origin.

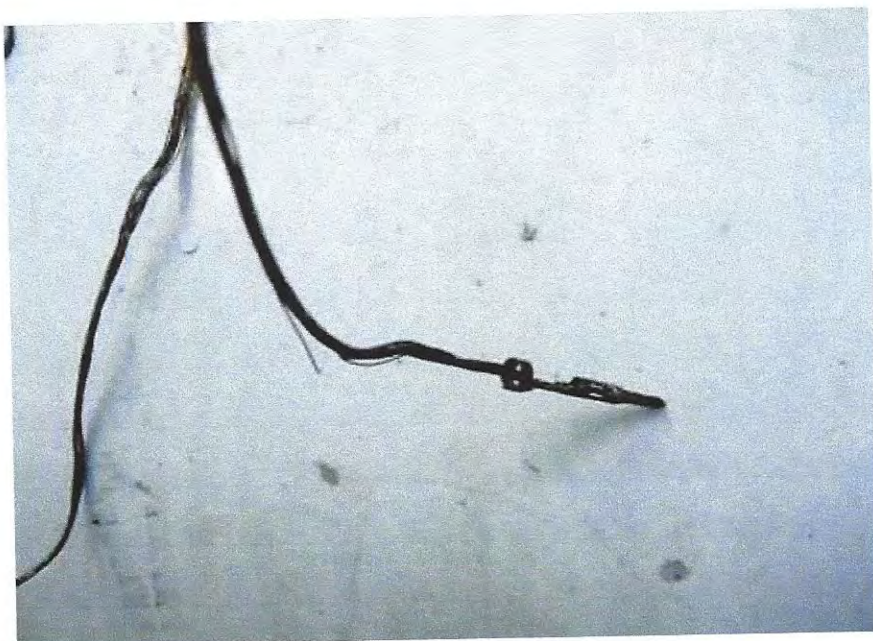
View of flasher wiring

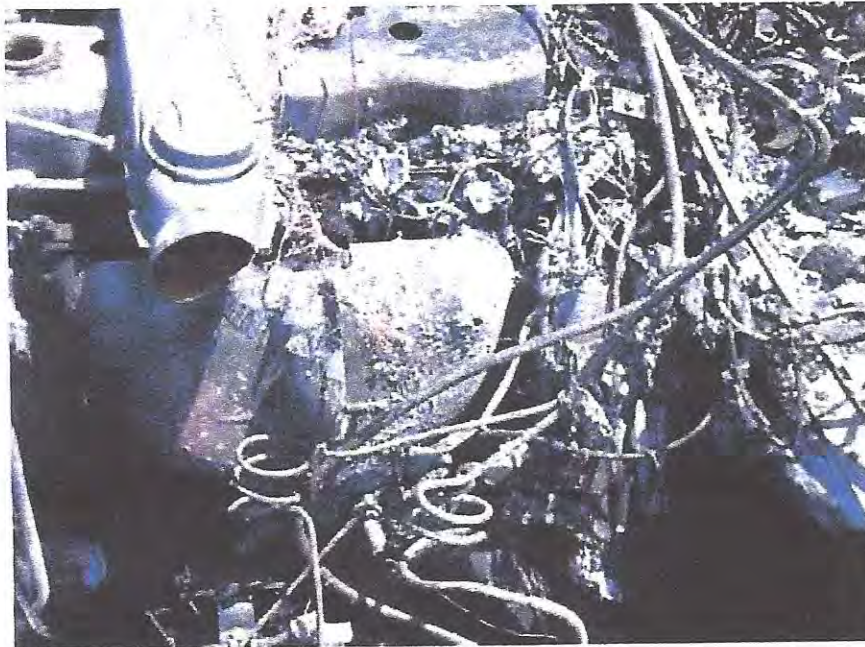
1. The origin of the fire was in the engine compartment on the left side.
2. The vehicle's fuel system is located in this area.
3. The cause of this fire is found to be a failure of the rubber fuel lines leading from the fuel filter.
4. These fuel lines are located in a very close proximity to the engine manifold.
5. The failure of the fuel lines would have been the result of thermal breakdown of the rubber lines from the heat of the manifold.

Fuel line failure.

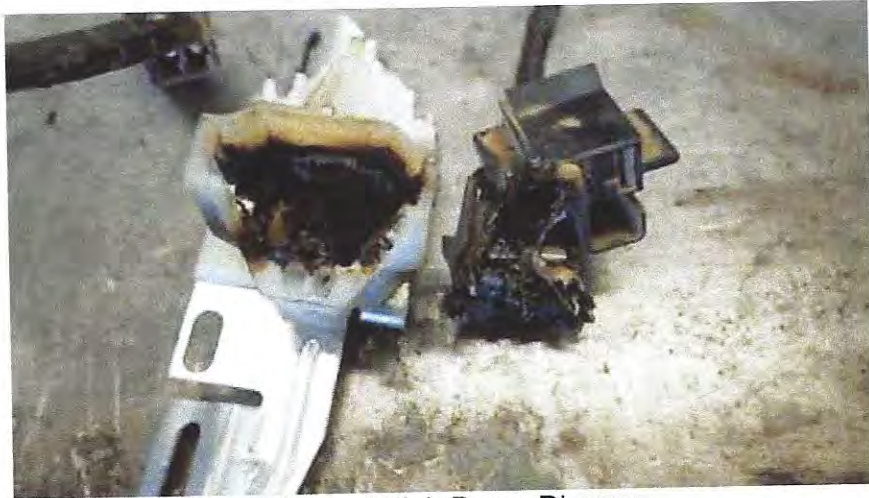
design. This resistance results in substantial internal power dissipation and eventual overheating and ignition of internal plastic parts.

Failure of High Beam Dimmer

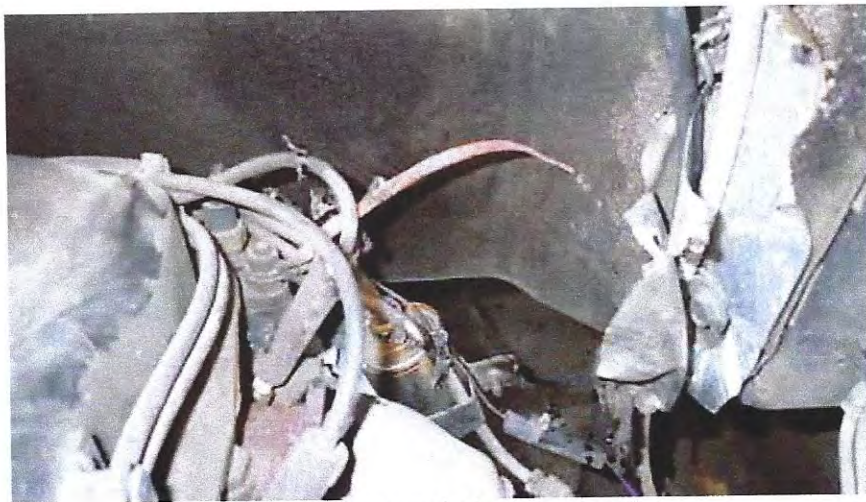
View of ground strap severed

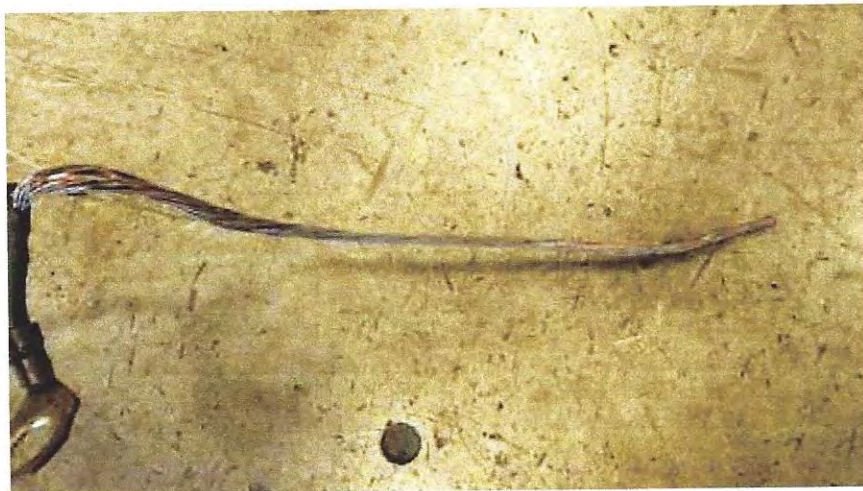
View of ground wire

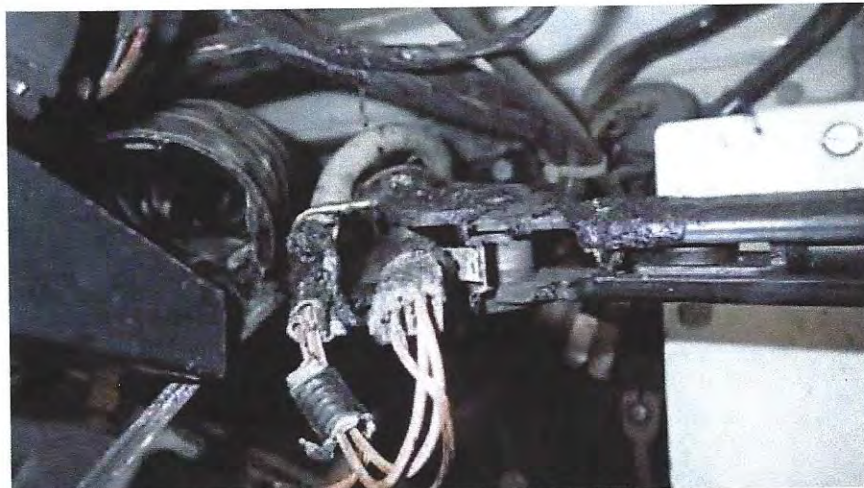
1. Three separate fire events occurred within this vehicle.
2. There is a possibility that the three events could be associated.
3. A determination of which event occurred first is not possible.
4. After a complete investigation of this fire loss, Trident has determined this fire to be undetermined in nature.
5. Any further information found involving this type of problem in other vehicles may lend information as to the origin and cause of this fire.

Three separate and distinct electrical events.

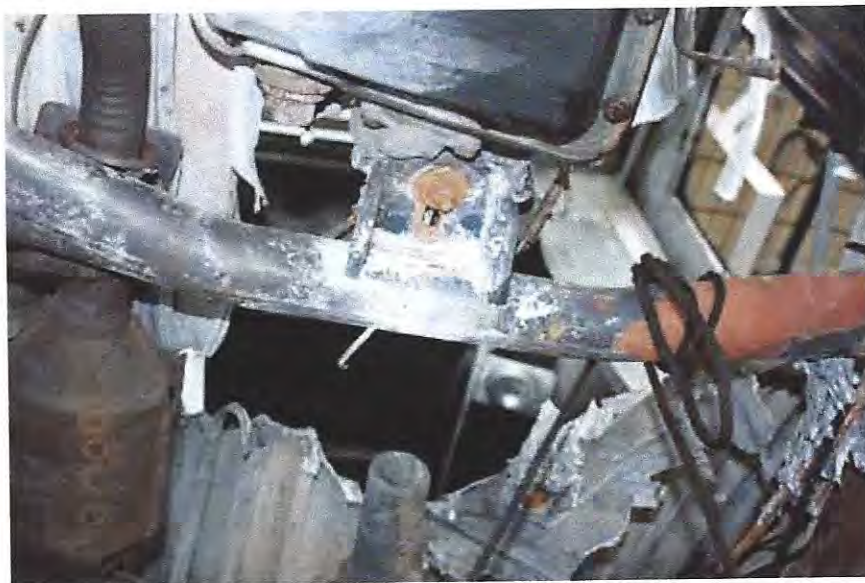
1. The area of origin for this fire was determined to be the underside of the vehicle in the center; specifically, near the transmission and driveshaft.
2. The point of origin was determined to be the driveshaft connection at the rear of the transmission.
3. The mechanical failure of the driveshaft caused sparks. The ignition source was fueled by the leaking oily fluid (transmission) which was sprayed backwards on the undercarriage of the LLV.
4. The cause of this fire is determined to be a mechanical failure, with the failure of the tail shaft seal causing the driveshaft to disconnect from the transmission.

View of hole/fire pattern, point of origin.

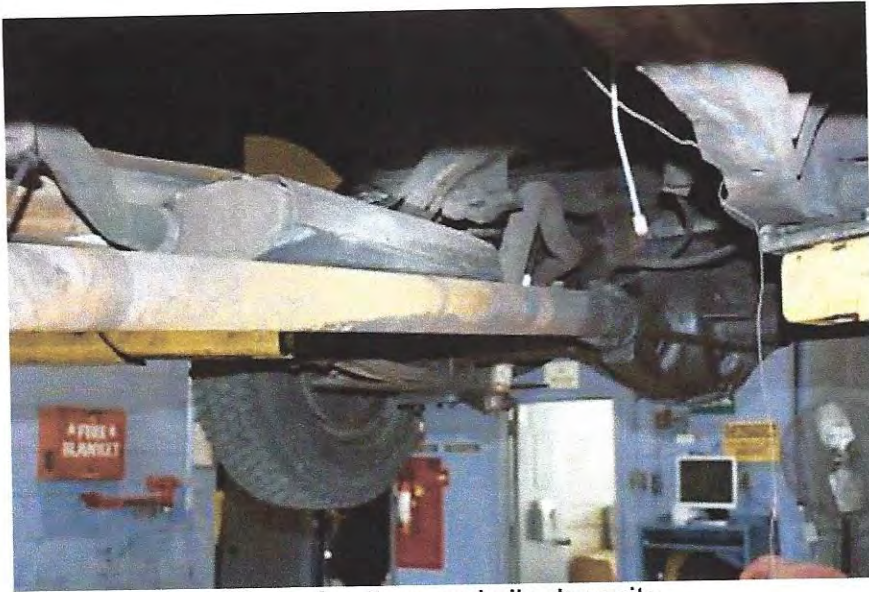
View of pattern and oily deposits.

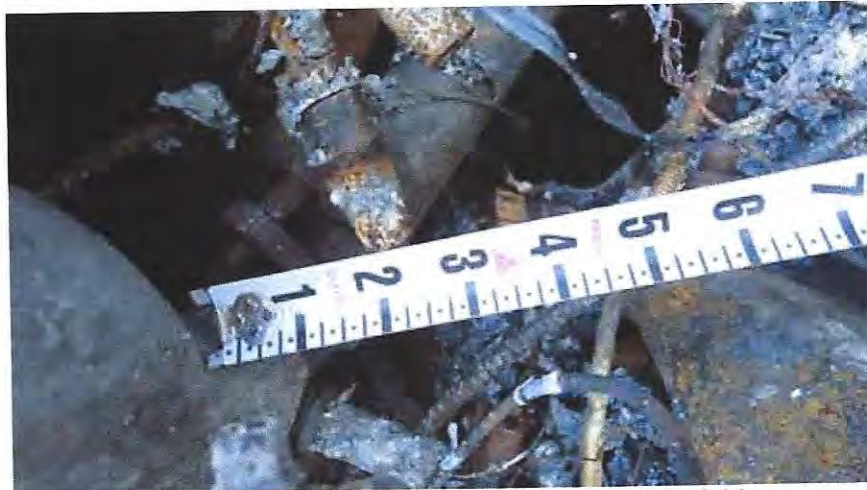
1. The origin of the fire was in the engine compartment on the left side.
2. The vehicle's fuel system is located in this area.
3. The cause of this fire is found to be a failure of the rubber fuel lines leading from the fuel filter.
4. These fuel lines are located in a very close proximity to the engine manifold.
5. The failure of the fuel lines was the result of thermal breakdown of the rubber lines from the heat of the manifold.

Fuel line failure due to distance from manifold.

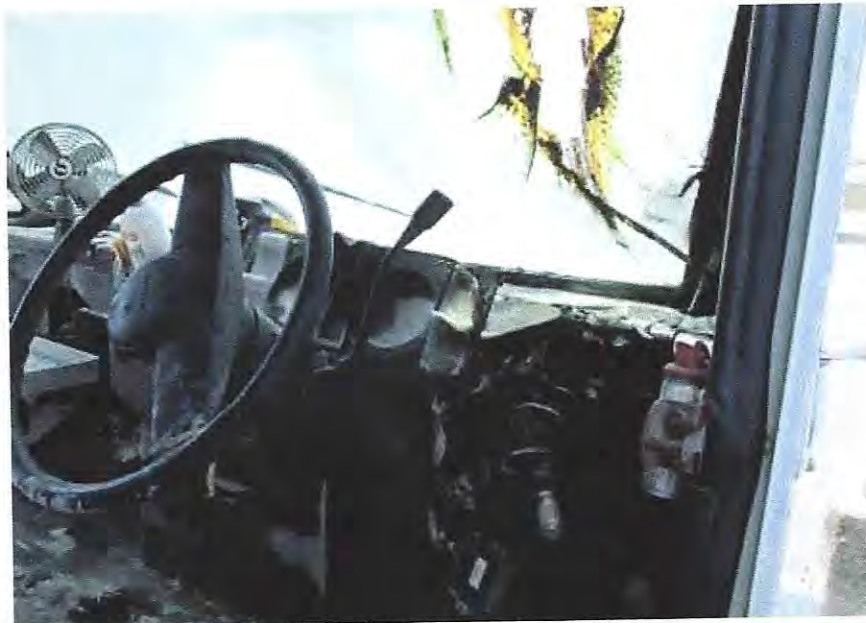
View of vehicle stored condition.

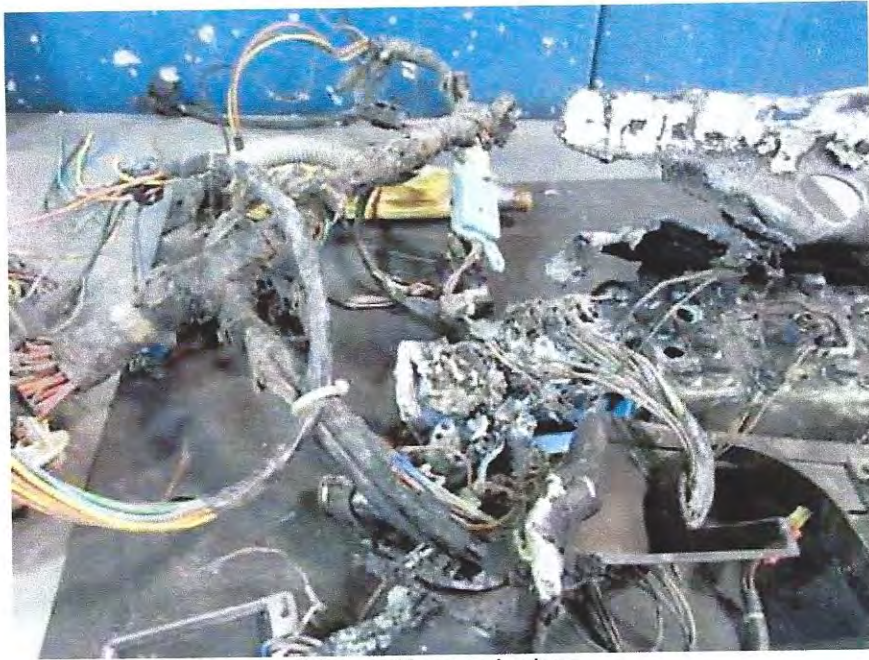
The examination of the photographs revealed fire damage to the interior dash of the LLV. The lower right side of the dash revealed the most damage. This area is where the flasher switch is located.

View of burned wires.

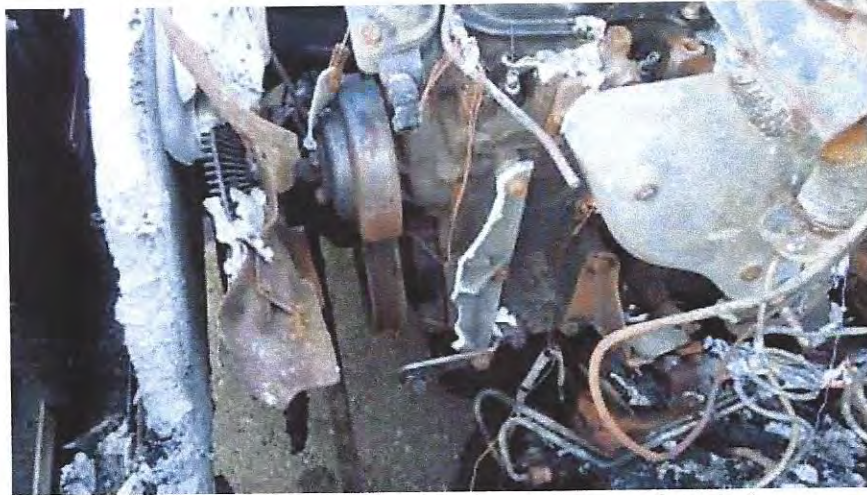
The lack of dirt, grime or debris on the fracture surface indicates that the fracture is recent and a crack which caused the fracture examined was not present for an extended time.

The presence of many small cracks (with clean surfaces) on the surfaces of the bracket indicates that the bracket was subject to a distributed stress not a localized stress. It is likely that because the bracket was secured to the engine with bolts, thermal expansion during the fire stressed the bracket and created many small cracks on all surfaces.

1. The fracture surface which allowed separation of the pump bracket was not present for a length of time sufficient for it to accumulate debris or grime;
2. The many small cracks and blisters, and probably the fracture itself, were the result of thermal stresses which occurred as a result of the fire.

Possible failure of power steering pump bracket.

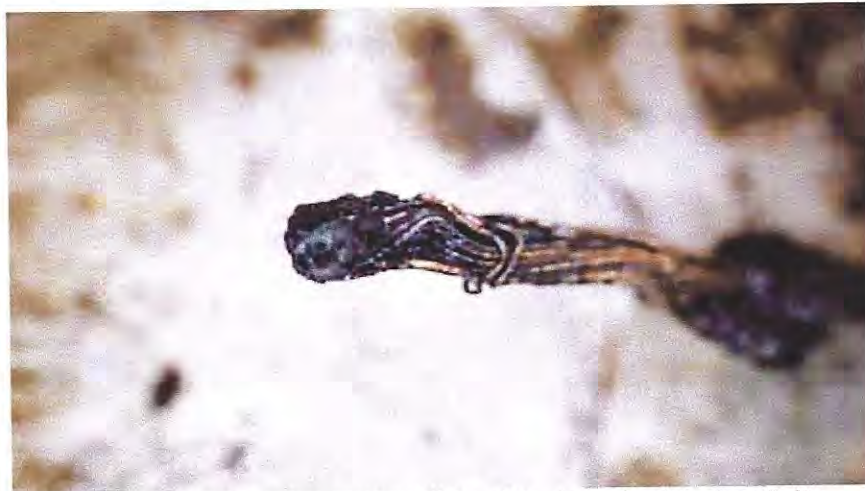
1. All fire damage and fire patterns revealed the fire to have originated in the passengers' compartment.
2. Examination of the passengers' compartment (area of origin) determined the fire originated at the blower motor located at the bulkhead on the left side of the vehicle.
3. After a complete investigation of this fire, Trident has determined the fire to have originated at the failure of the wire connection to the blower motor mounted on the left side interior bulkhead of the vehicle (point of origin).

View of blower wire connection showing electrical activity

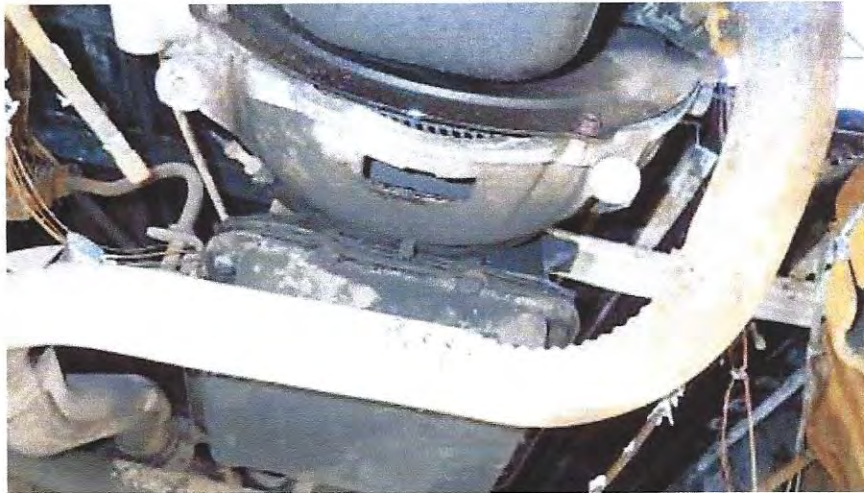
1. The area of origin for this fire was determined to be the underside of the vehicle in the center; specifically, near the front of the transmission under the bell housing.
2. The point of origin was determined to be the front of the transmission under the bell housing.
3. The mechanical failure of the fluid leak caused a hot surface ignition. The ignition source was fueled by the leaking transmission fluid, which was sprayed backwards onto the undercarriage of the LLV, and nearby fuel lines.
4. The cause of this fire is determined to be a mechanical failure, with the failure of the torque converter front pump seal causing transmission fluid to leak onto the exhaust pipe.

View of transmission bell housing leak.

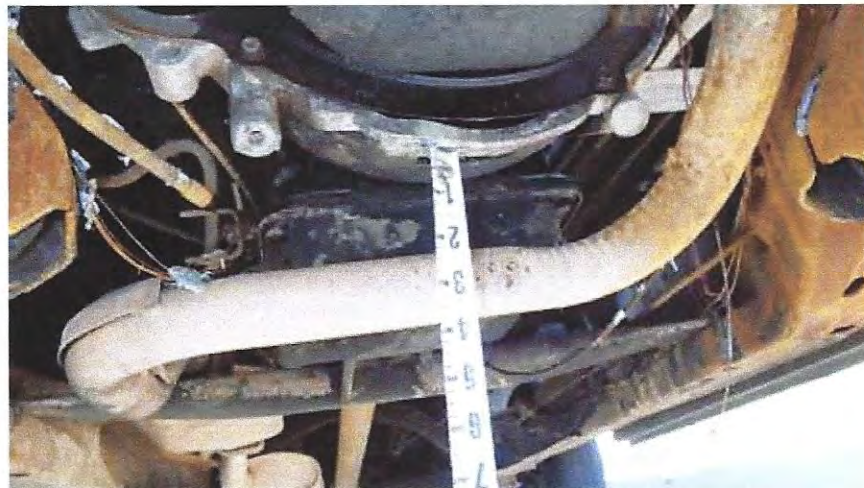
View of point of origin.

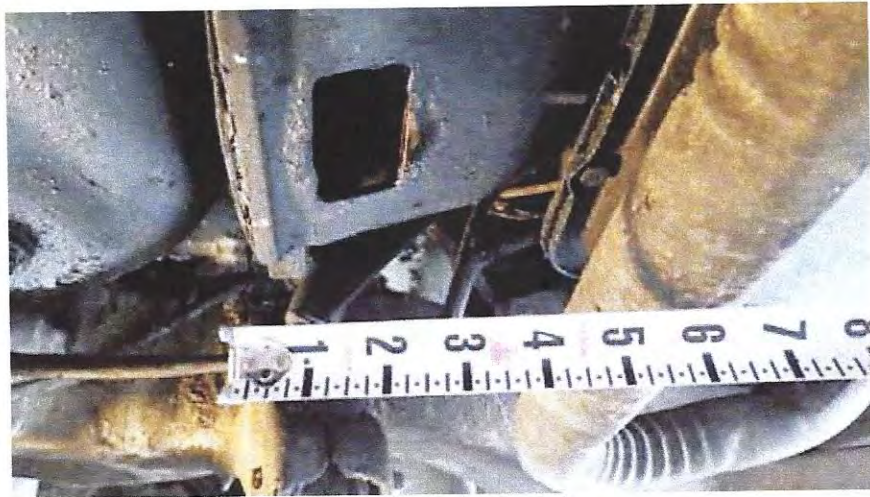
1. The area of origin for this fire was determined to be on the underside of the vehicle in the center; specifically, near the rear of the engine and the front of the transmission.
2. The point of origin was determined to be the crossover exhaust pipe underneath the rear of the engine and the front of the transmission.
3. The mechanical failure of the oil leak caused a hot surface ignition. The ignition source was fueled by the leaking rear main seal which sprayed oil backwards onto the undercarriage and exhaust of the LLV.
4. The cause of this fire is determined to be a mechanical failure, with the failure of the rear main engine seal causing motor oil to leak on to the exhaust pipe.

View of point of origin.

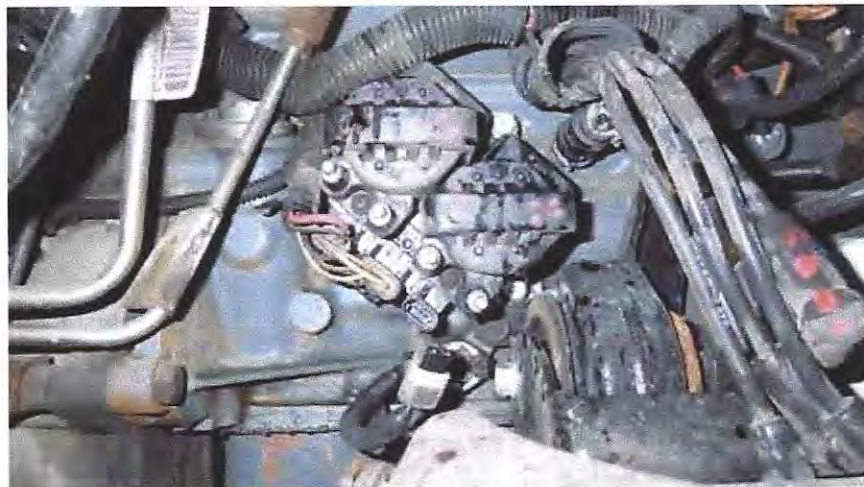
View of coil

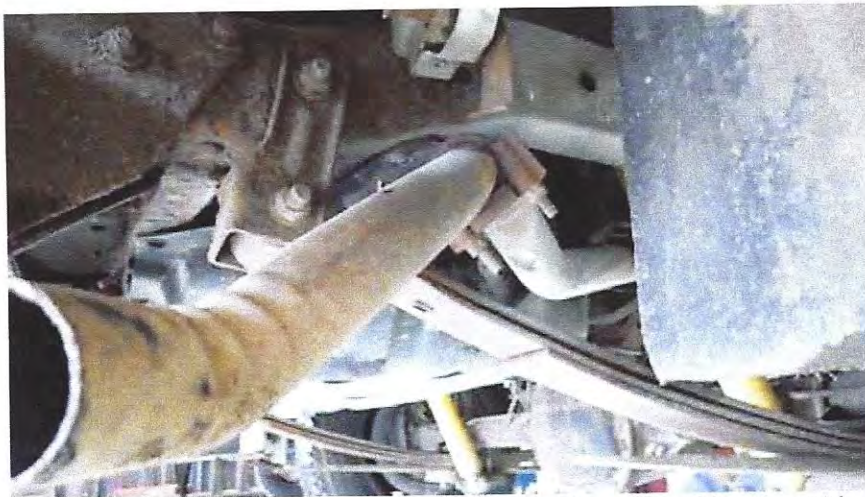
1. The vehicle was started and operated while not running properly.
2. The vehicle's tail pipe had been broken away from its mount for an extended period of time.
3. The broken tail pipe causing sparks was determined to be the source of ignition.
4. The bad coil causing raw gasoline to be forced out the tail pipe was determined to be the first fuel ignited.

Vehicle being operated in poor condition with faulty coil and bent and broken tail pipe.

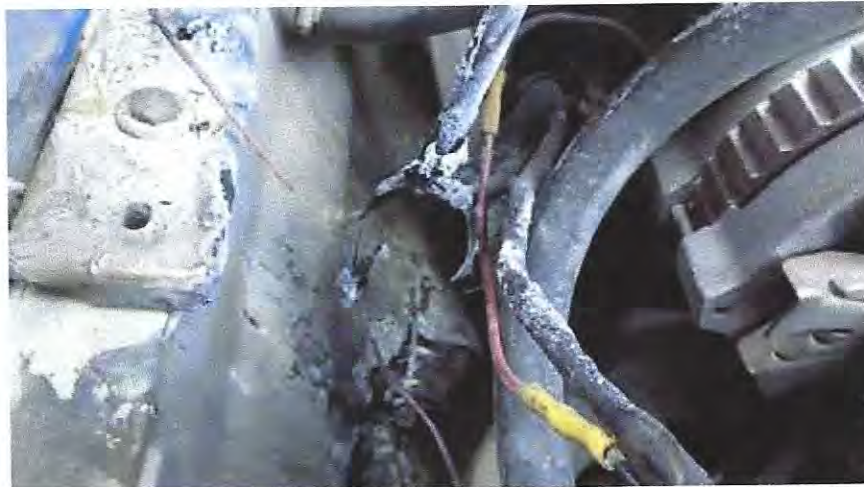
Ground wire from Negative Battery terminal, overheated and shorted out.

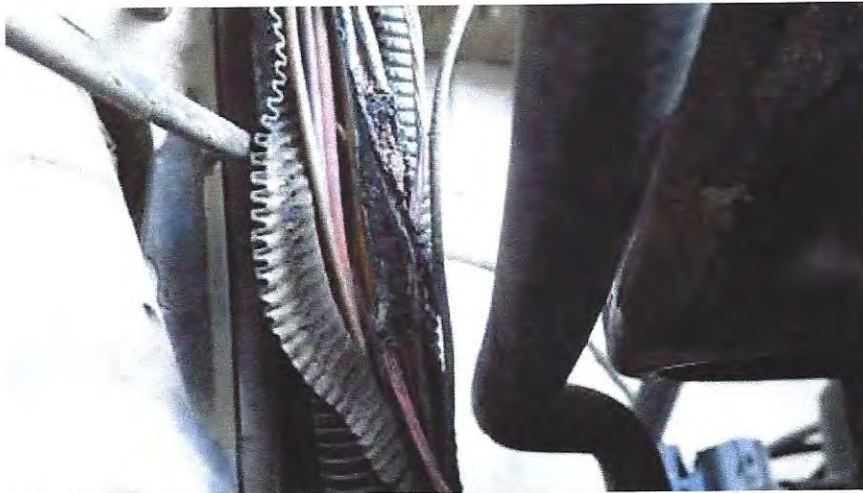
Ground wire inside of the main engine wiring harness, heated up causing a short.

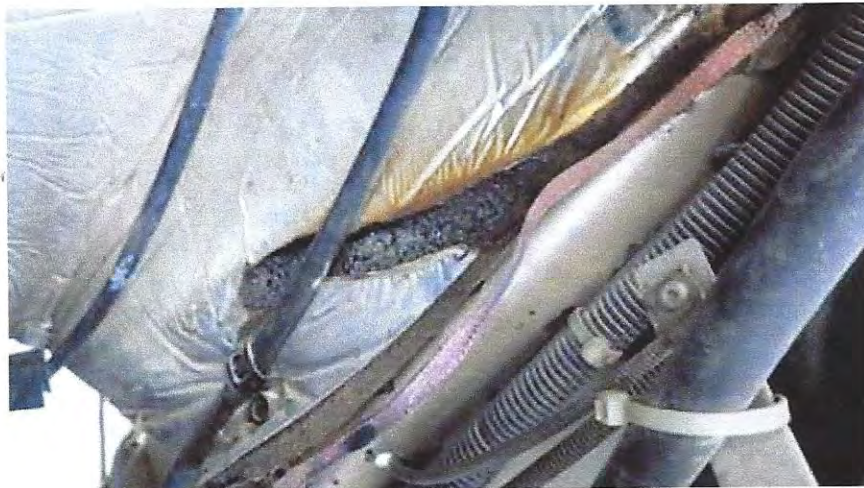
Ground wire for ECM overheated and shorted out.

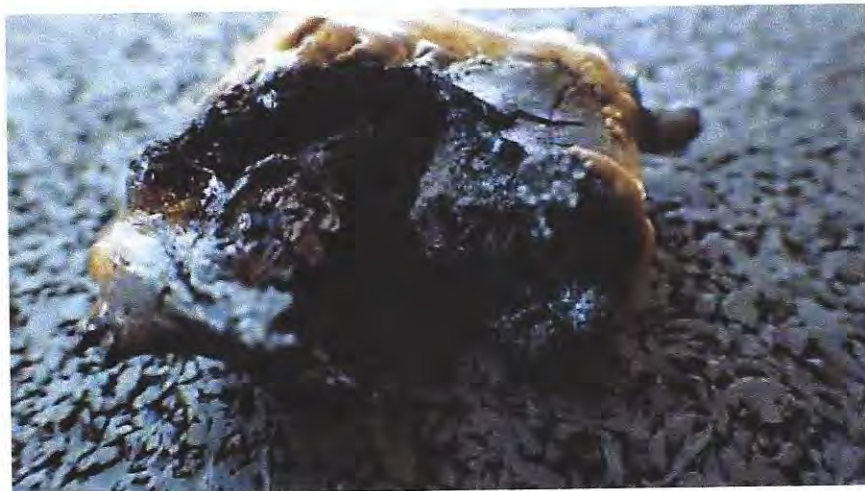
1. A jumper fuse was used in place of the fuse panel fuse holder.
2. This fuse jumper failed, heating to ignition.

The use of a jumper fuse instead of fuse block replacement.

Trident's interview of the carrier, and examination of the vehicle currently used, determined that fuse jumpers are used to bypass non-working fuse holders in the fuse panel. The involved vehicle had a failure of one of these fuse jumpers. Other than smoke damage, there was no fire damage to the vehicle itself. The use of these fuse jumpers instead of replacing the wiring harness and fuse panel should only be done as a temporary measure.

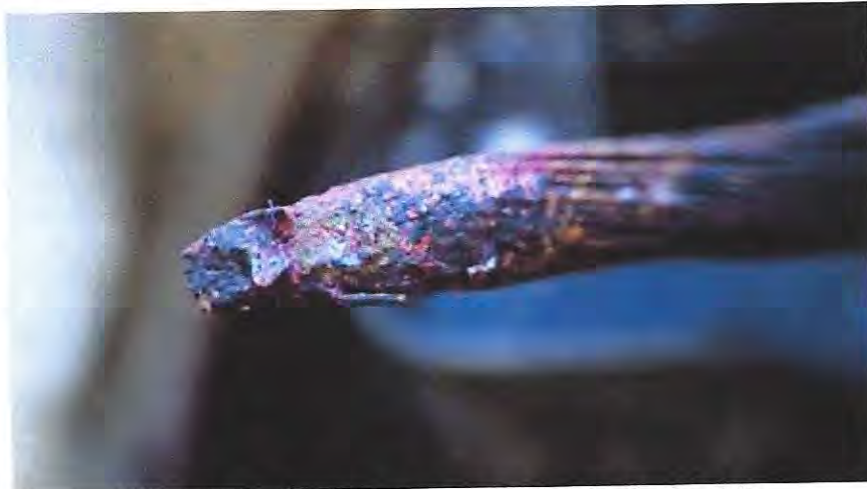
1. The area of origin for this fire was determined to be the engine compartment; specifically, near the right side (driver's side) of the engine.
2. The point of origin was determined to be the positive battery cable.
3. The mechanical failure of the starter caused the positive battery cable to over-current/heat. When the wire failed, it caused an arc which ignited nearby combustibles and fuel.
4. The cause of this fire is determined to be a mechanical failure. The failure of the starter, remaining engaged, caused a constant flow of current from the battery. This over-current produced heat.

View of arc damage to the positive battery cable.

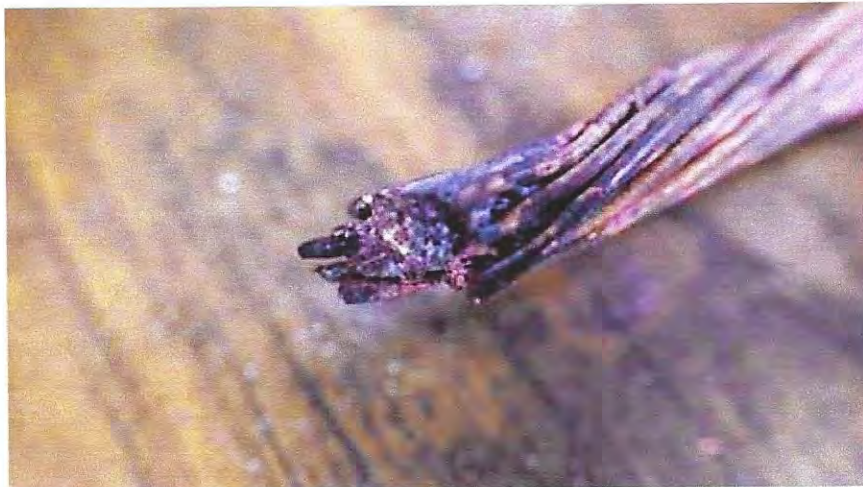
1. This fire originated at the right front of the engine compartment.
2. The missing section of the wire leading from the alternator to the battery is the probable failure point.
3. The failure of the wire leading from the alternator to the battery, with its close proximity to the transmission cooler lines and the possibility of the mesh sleeve being worn from the lines, leaves the plastic inner lining and combustible fluid inside as a catalyst for the fire.

Failure of wire leading from alternator to battery.

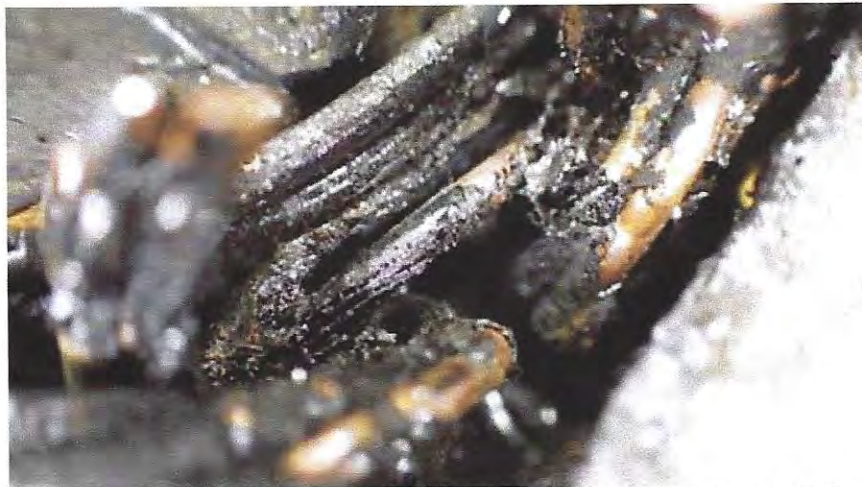
Evenly overheated high current windings in the stator section of this alternator indicate that heating was internal to the alternator. This overcurrent condition was most likely the result of shorted electrical rectifiers on the rectifier assembly within the al-

Comparison of inner and outer stator high current windings with partial removal of outer windings.

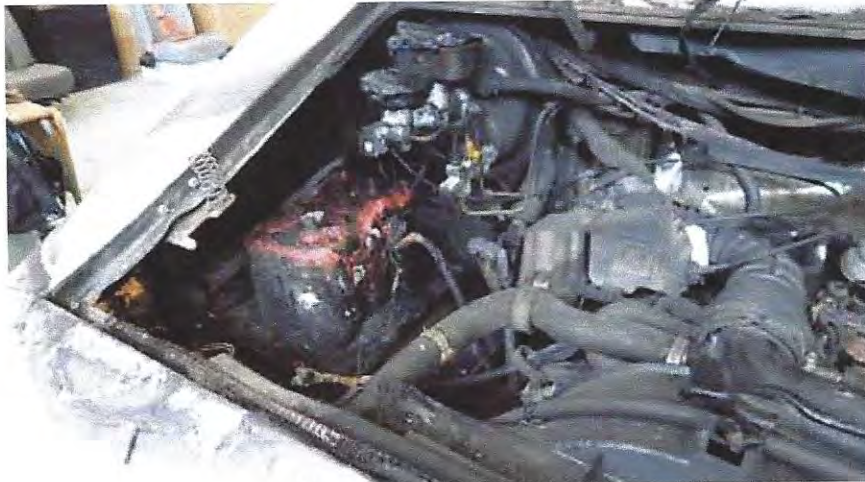
1. The area of origin for this fire was determined to be the engine compartment; specifically, near the right side (driver's side) of the engine.
2. The point of origin was determined to be the battery.
3. The failure of the battery caused an overcurrent/heat. When the battery failed, it created a fire which ignited nearby combustibles and fuel.
4. The cause of this fire is determined to be a mechanical failure, with the failure of the battery thus causing an overcurrent. This overcurrent caused excessive heat.

View of area of origin.

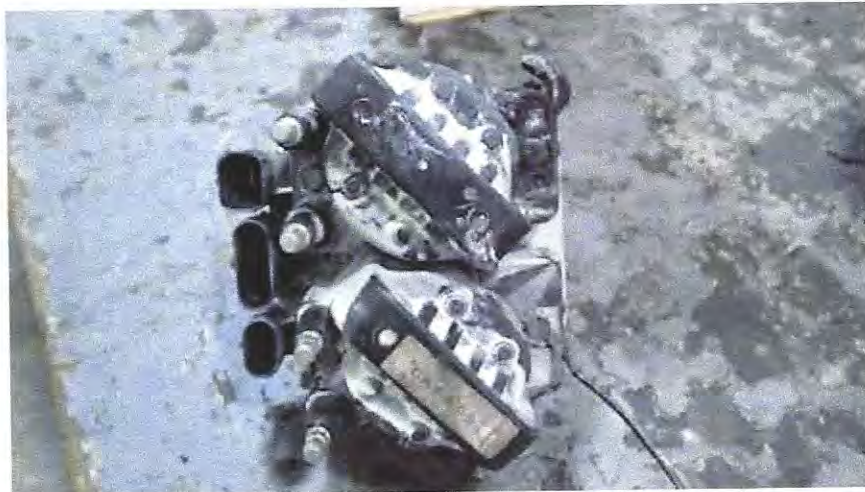
1. The area of origin for this fire was determined to be the engine compartment; specifically, near the right side (driver's side) of the engine.
2. The point of origin was determined to be the distributorless ignition system.
3. The failure of the distributorless ignition system caused it to produce an over-current/excessive heat situation. When the ignition system failed, it caused an arc which ignited nearby plastic combustibles.
4. The cause of this fire is determined to be a mechanical failure.

View of distributorless ignition coil cracked housing.

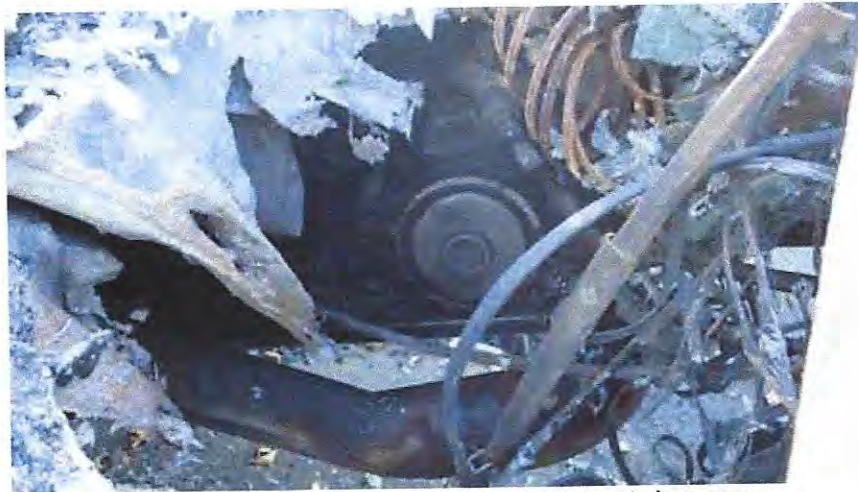
1. The area of origin for this fire was determined to be the engine compartment. Specifically near the right side by the firewall.
2. The point of origin could not be determined do to the lack of information and severe fire damage.
3. After a complete investigation of this fire loss, Trident has determined this fire to be undetermined in nature.

View of right side engine compartment damage.

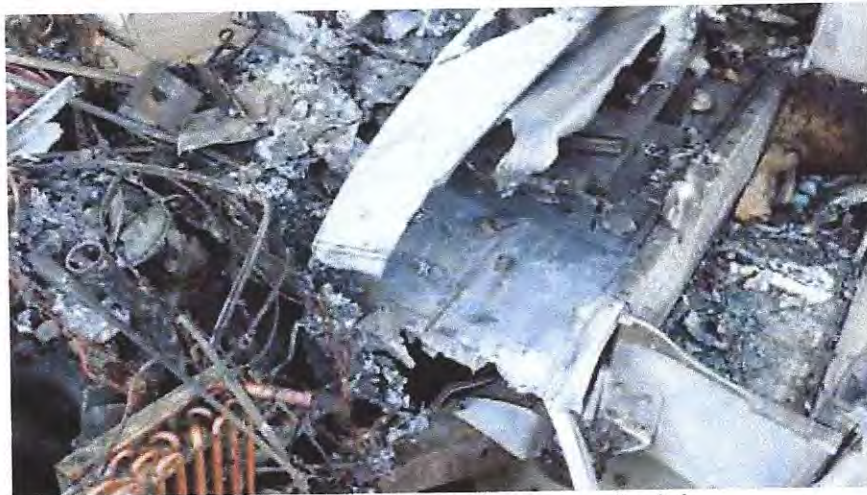
1. All fire damage to the involved vehicle showed the fire to have progressed from the front of the vehicle to the rear.
2. Examination of the engine compartment showed the fire originated on the left side of the engine and progressed toward the rear of the vehicle.
3. The area of origin could be determined as the left side of the Engine; however, due to the extent of fire damage to the area of origin, no point of origin could be determined.

View of left side of engine area of origin.

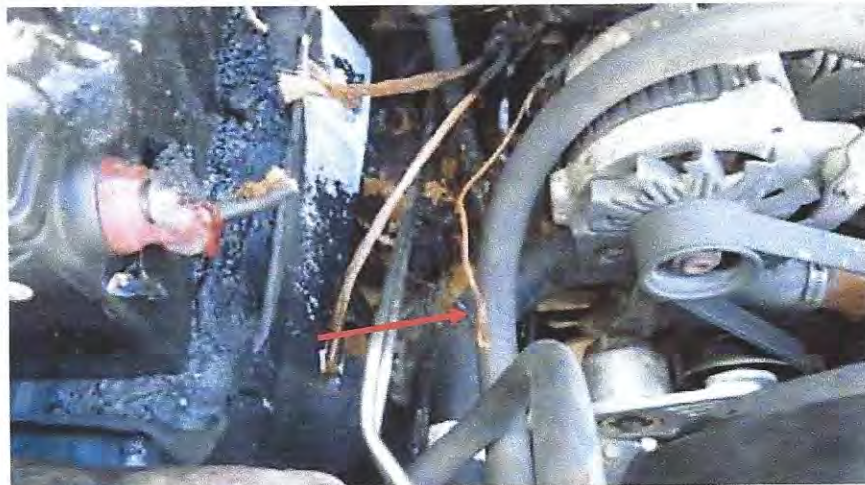
1. The origin of this fire is located at the wiring from the positive battery terminal.
2. The failure of the wire leading from the alternator is the point of origin for this fire.
3. Examination of the alternator will likely provide the necessary information that a failure in the alternator will cause excessive amperage to flow to the battery.

View of point of origin wire leading from alternator to battery.

The fire damage to this vehicle was similar to other vehicles that had a failure of the wire leading from the battery to the alternator. As noted in prior reports, the wire leading from the alternator to the battery should be equipped with a fusible link. A fusible link in this wire would reduce the number of fire related failures to this wire.

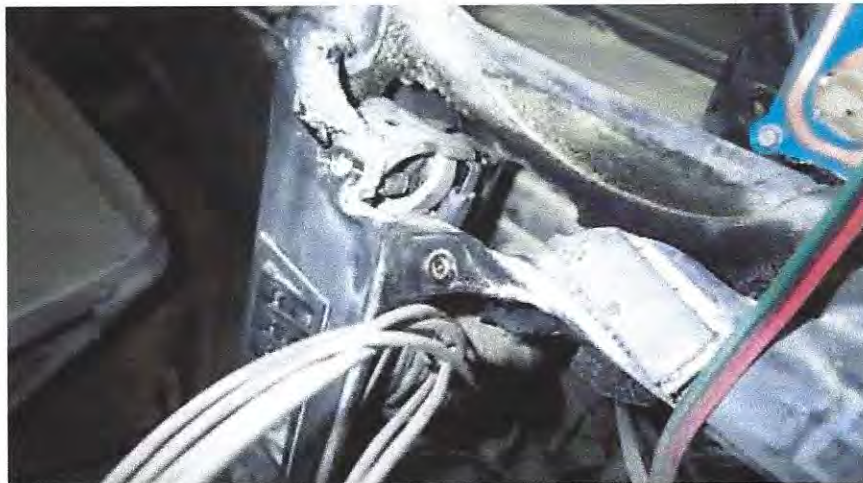
1. The area of origin for this fire was determined to be the passenger's compartment. Specifically the dash area on the interior.
2. The point of origin was determined to be the headlight switch.
3. The failure of the headlight switch caused it to produce an over current/excessive heat situation.
4. After a complete investigation of this fire loss, Trident has determined this fire to be a mechanical failure.

View of point of origin headlight switch.

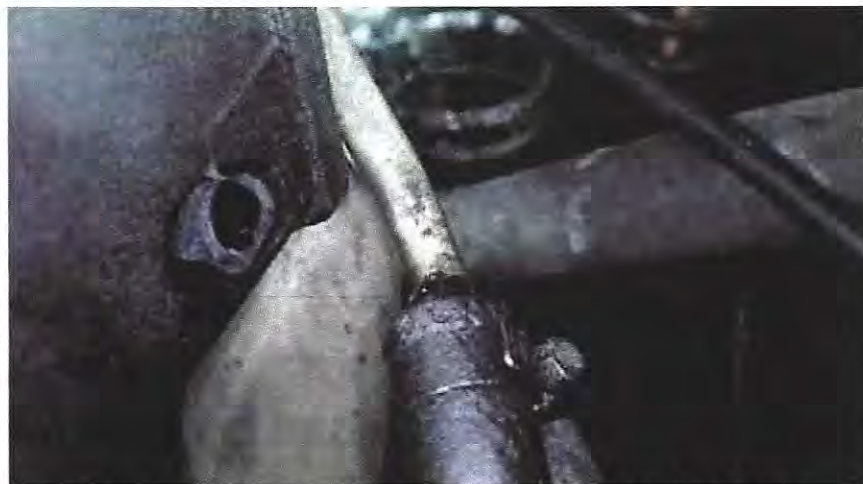
1. The area of origin for this fire was determined to be the engine compartment.
2. The point of origin was determined to be the exhaust manifold.
3. The failure of the serpentine belt caused it to break the power steering return line, spraying fluid over the hot exhaust manifold which ignited.
4. After a complete investigation of this fire loss, Trident has determined this fire to be a mechanical failure.

Close up view of broken P/S return line, point of origin.

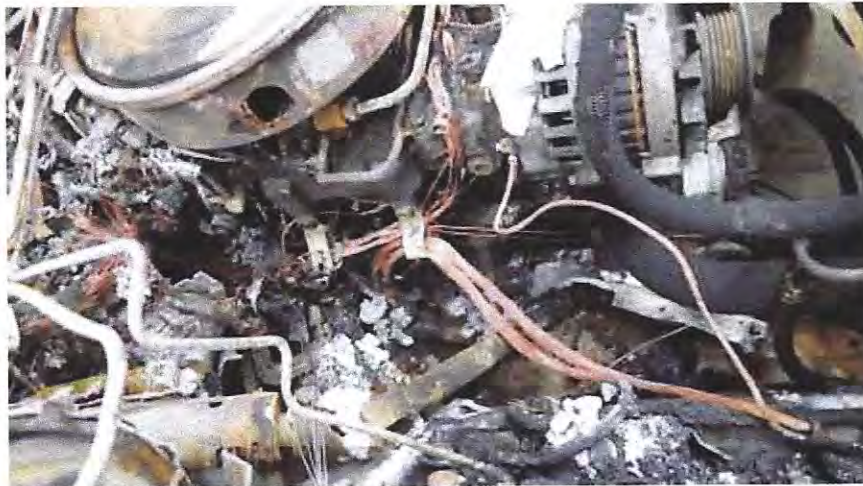
Trident's attempt to examine the loss location was not possible due to snow cover. The first fire noted by the carrier was located at the headlight switch. Examination of this area revealed no remains of the switch. The examination of the battery showed evidence of internal heating. This can be a result of overload. With the internal windings of the alternator being seized a failure of the alternator will need to be ruled out if possible.

1. The first fire noted was at the headlight switch.
2. The alternator was seized indicating a possible failure.
3. The battery exhibited signs of internal heating.
4. The above information requires that the alternator be examined for possible failure.
5. The failure of the alternator can cause an overload of the electrical system that can cause a failure at the weakest point the overload encountered.
6. Trident had determined that this fire is electrical in nature with the first failure to be determined thru testing of the alternator.

View of alternator and associated wiring.
